e-F@ctory

Case study

Collision detection system reduces 79% of machine tool repairing costs!

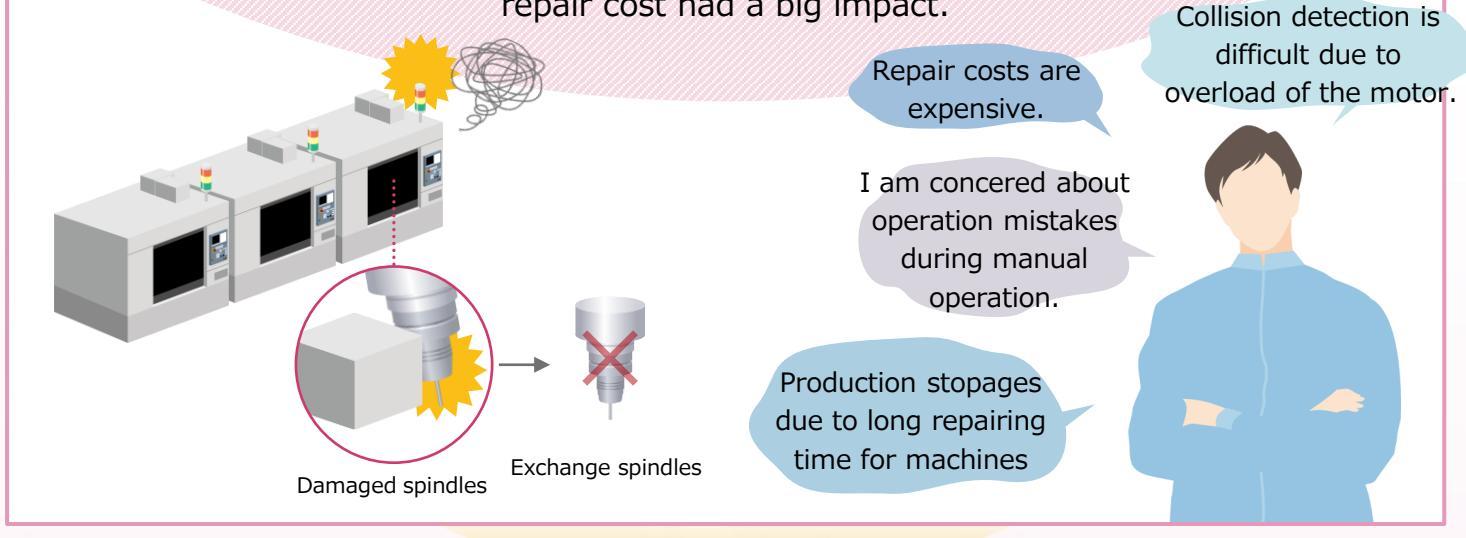
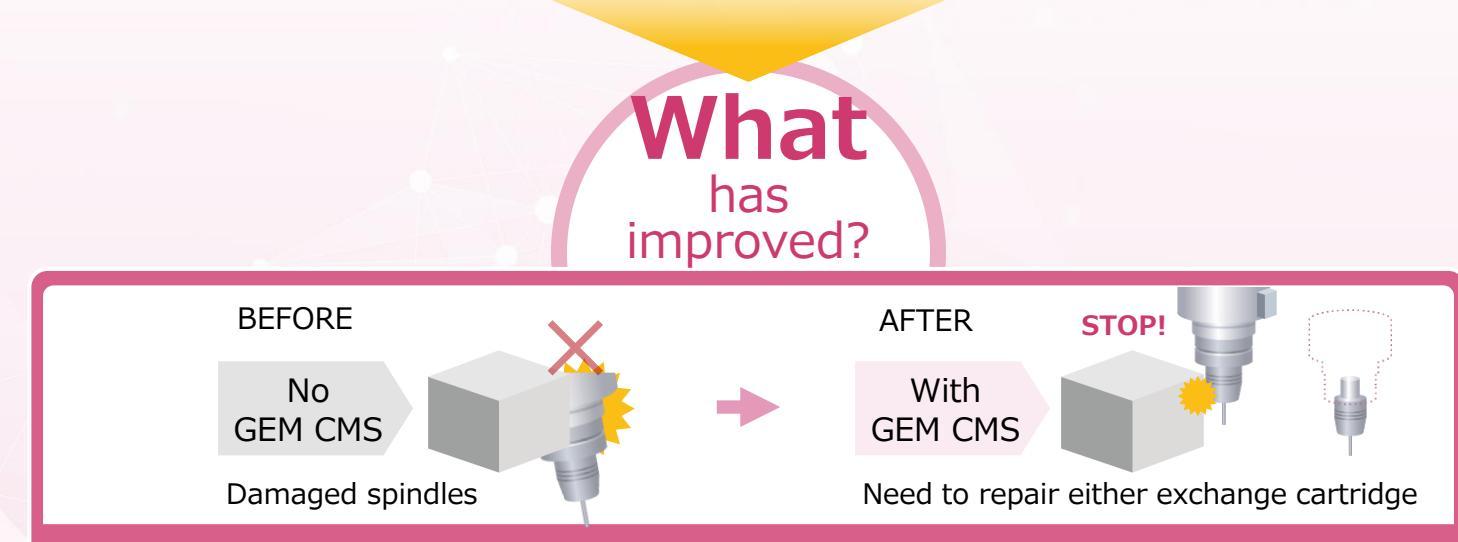
With the introduction of the "Collision Detection System GEM CMS", the machine can be stopped automatically in the event of a collision, and damage can be minimized. Collisions requiring spindle replacement have been reduced (12 times / year \rightarrow 2-4 times / year), leading to a significant reduction in repair costs and downtime. In addition, it was visualized by the log function and the cause was clarified.

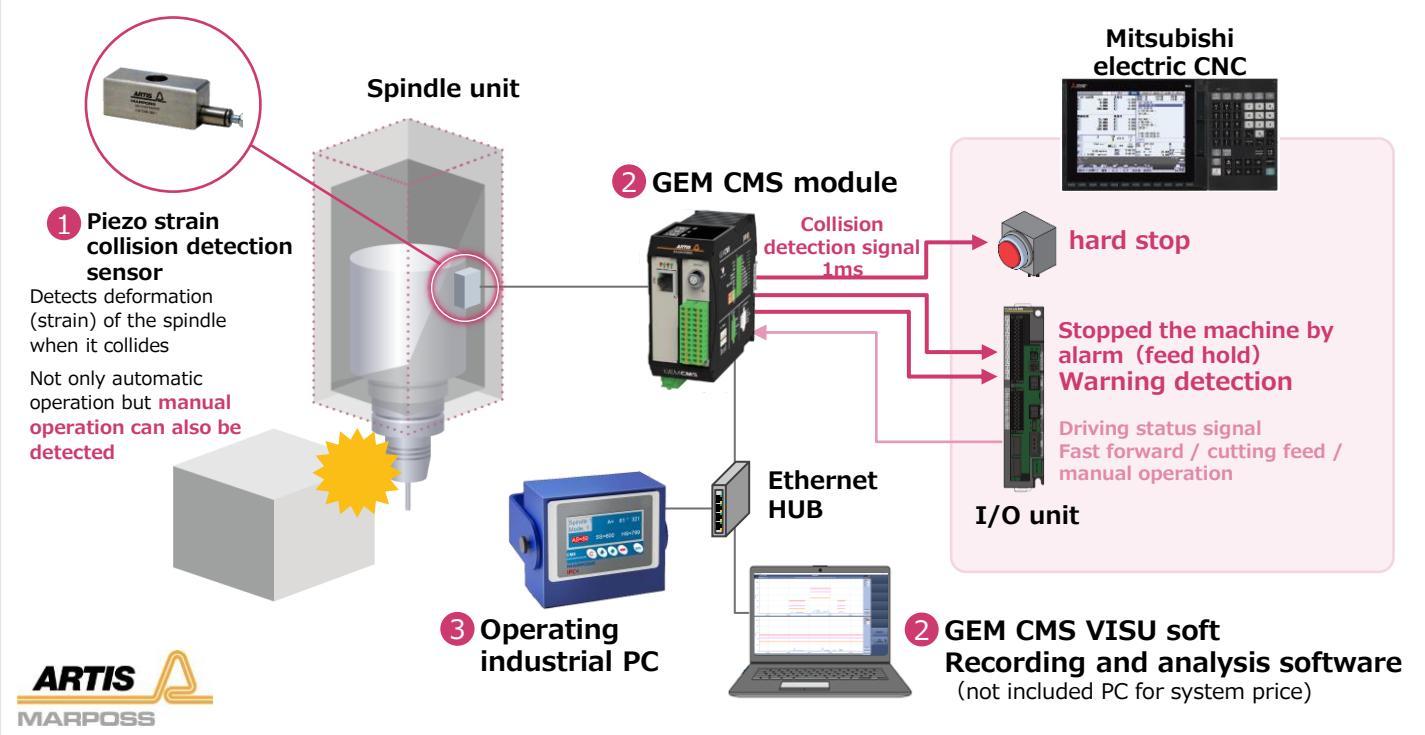
The collision detection sensor is installed on the machine tool spindle unit. When a collision occurs in a machine, a collision detection signal is output to the CNC within 1 msec after the collision is detected to stop the machine and minimize the damage to the machine. In addition, it is possible to switch between three types of output signals (emergency stop, alarm stop by feed hold, warning display) by setting the detection threshold value, and control according to the collision situation.
